Introduction

Sampling sites and windmill locations

Observations and description of water plant communities at each site

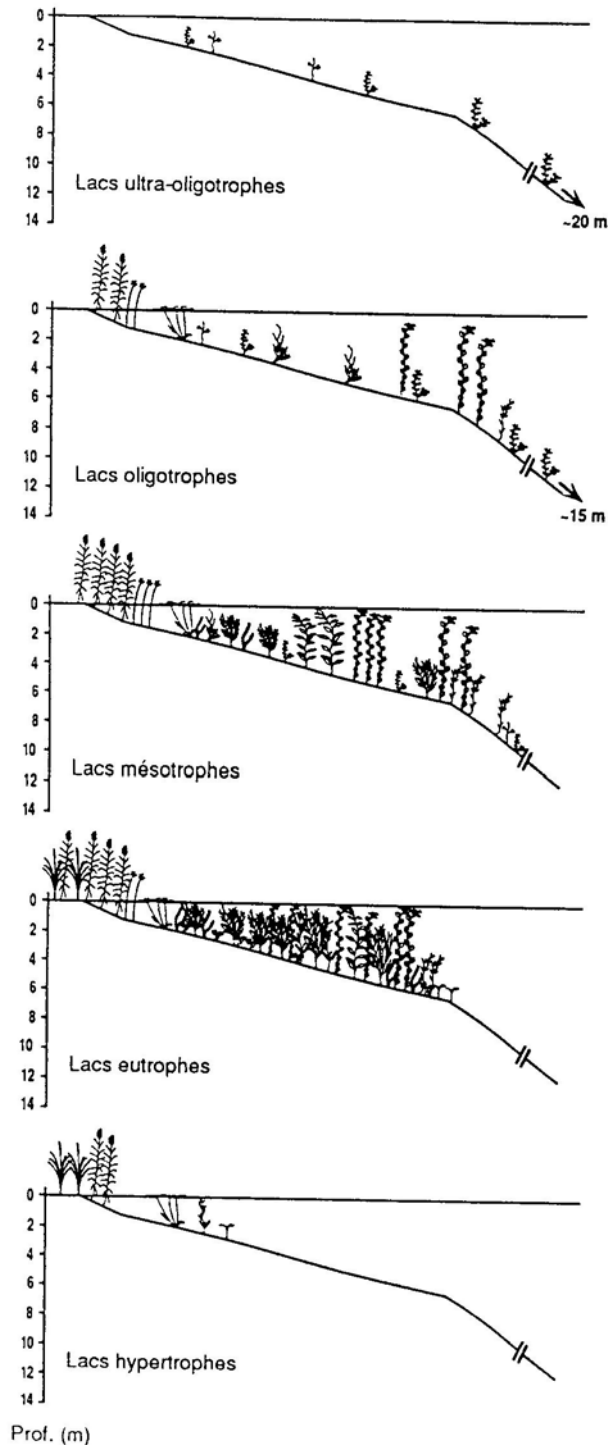
As for the surrounding areas near the windmills we have observed more than just a reduction of Milfoil communities, in fact a radical change in different types of plant communities can now be seen.

The change in types of plant communities demonstrates that the effect of the windmills is real. What we now observe around the windmills is a shift towards typical plant communities found in oligotrophic lakes, the **ULTIMATE GOAL** of this restoration project that began more than 5 years ago.

← Type of plant communities found around the windmills in 2005

← Type of plant communities in 2005 without the windmills

← Type of plant communities before 2005 without the windmills
