Control of Eurasian Milfoil (*Myriophyllum spicatum*) using wind powered water circulators at Lake Cayamant, Quebec, CANADA.

August 2005

By : *Dany Boudrias*, aquatic ecologist
Eco-Guide International inc.

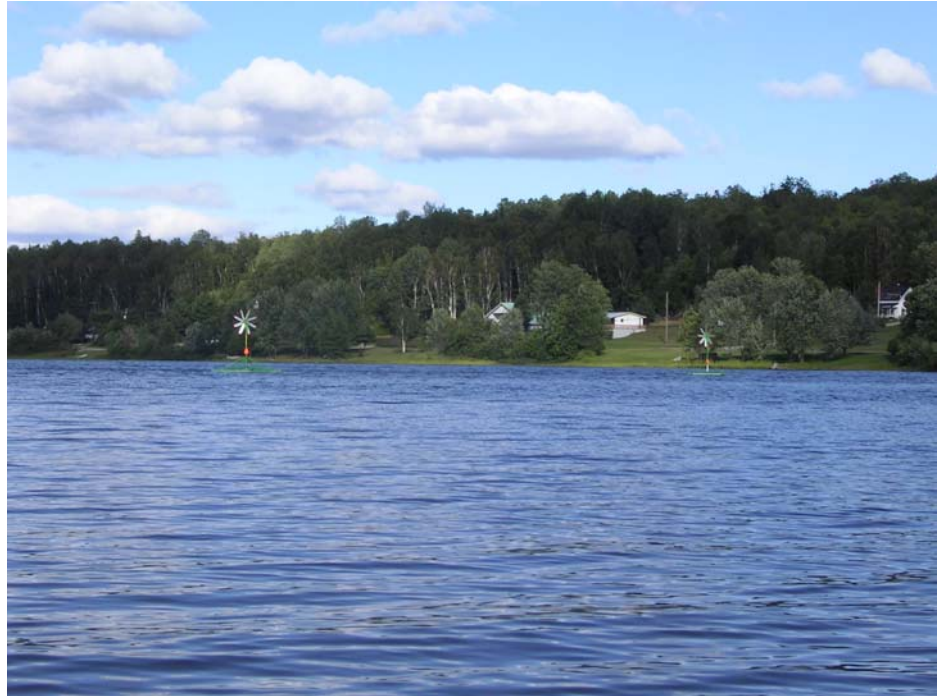
The windmills were located in an area with a depth of 2 to 2.5m. The density of the water plant community was of 2 to 3 stems per m². We found the majority of the Milfoil present in a state of degradation, with brown stems and foliage. When we created an ascending water current by rapidly pulling up a Secchi disc, the Milfoil plants would come apart easily as if dead. The brown coloration of the Milfoil at this location was an indicator that the plant could no longer photosynthesize and had reached a stage of early decomposition. The mean length of the remaining stems

was 1.2m, namely much shorter than the average length the Milfoil can usually reach (3 to 6m). An important fact to underline is the presence of *Elodea canadensis* (Canada Water-weed). This species was starting to colonise areas where Milfoil was once present. Considering that the few remaining Milfoils were practically dead, the dominant plant at this site was now Canada Water-weed.

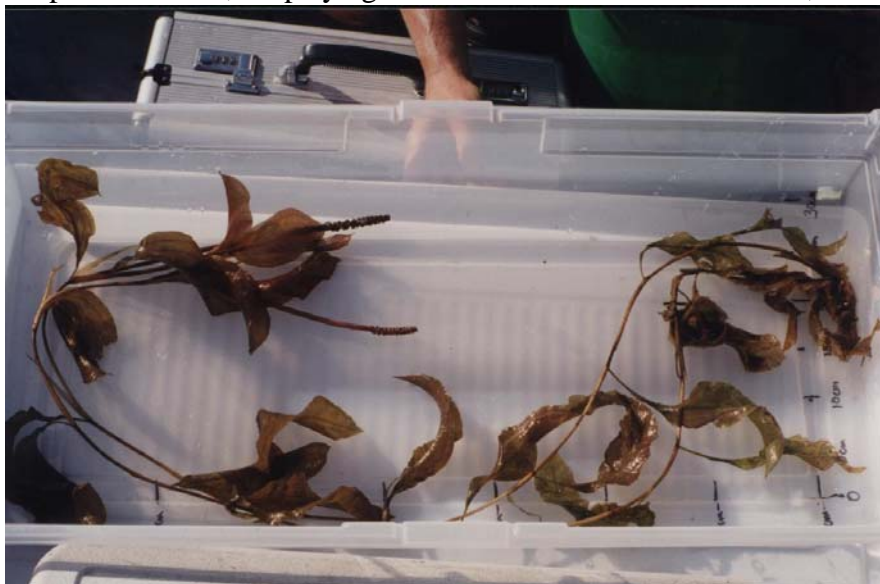
Moving from station 1 to station 2 we observed a transition zone of approximately 200m were a dominance of Canada Water-weed shifted towards a dominance of Large-leaved Pondweed (*Potamogeton amplifolius*) which finally ended with a dominance of Eurasian Milfoil.

When we reached station 2, Eurasian Milfoil was the dominant plant in the area. The Milfoil seemed to be in perfect health, displaying its usual characteristics such as; a high density of approximately 15-25 stems/m², all green without any signs of degradation as observed at station 1 and at least 2m in length. On the other hand, we did observe that it was generally shorter than what was observed previous years.

In previous years, not only would it reach the surface, but a mat of stem elongations would float on the surface of the water, which was not the case this year.
